## G. TRANSPORTATION

The town is a small “bedroom” community with a significant portion of Route 191 that serves as both “Main St.” and a regional collector road. Cooper is dominated by the condition of Route 191. It is considered “unbuilt” in transportation engineering terms and, before reconstruction on a small portion of Cooper Hill and some resurfacing in the summer of 2010, is in terrible condition throughout the town. This issue affects businesses, the overall safety and convenience of residents, as well as property values.

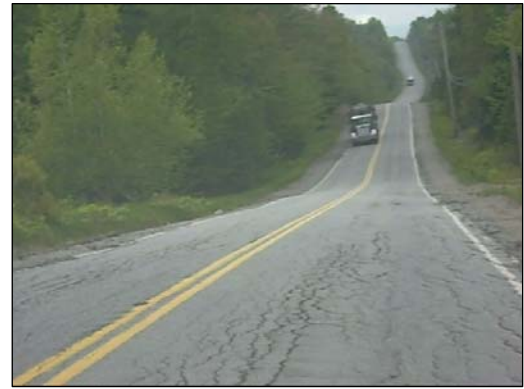
Photo point 2 – see Map 2

Overall, the public roadways in Cooper are in poor to fair condition. Route 191, the main travel way is in very poor condition. The town does not have a highway department but contracts for road services. Contracts are overseen by the Selectmen. The town works diligently with limited resources to maintain local roads.

The damage that does occur to our roads is largely the result of trucking activity. Harsh weather, which includes rapid changes in weather conditions, is another cause of road deterioration. Roads are most vulnerable to the weight of trucks and other heavy vehicles during the spring thaw, which is also a time of year when many natural resource-based products are transported to market.

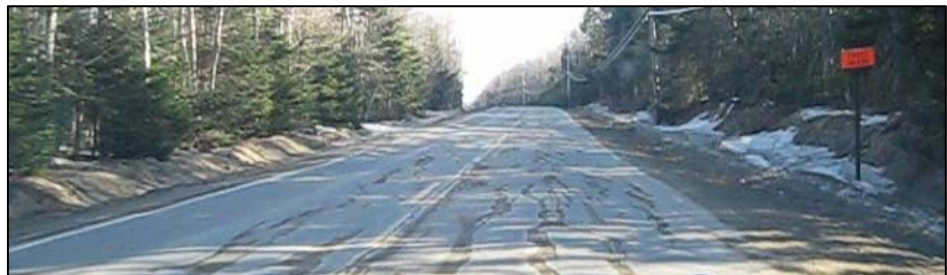
Photo Point 3 – see Map 2

The capital improvements proposed in the FY10-11 BCWP sought to address the abysmal condition of Route 191 in Cooper. The section of 191 in photo point 3 is part of the section of Cooper Hill that was resurfaced in July, 2010. There were dozens of long stretches of multiple longitudinal fissures in the

road surface that were 4-8 inches wide and, in some cases, 3-4 inches deep. These are unlikely to reappear where the road was fully reconstructed. Residents anticipate that the areas that were only resurfaced will very quickly return to their former condition due to heavy truck traffic and winter weather conditions.

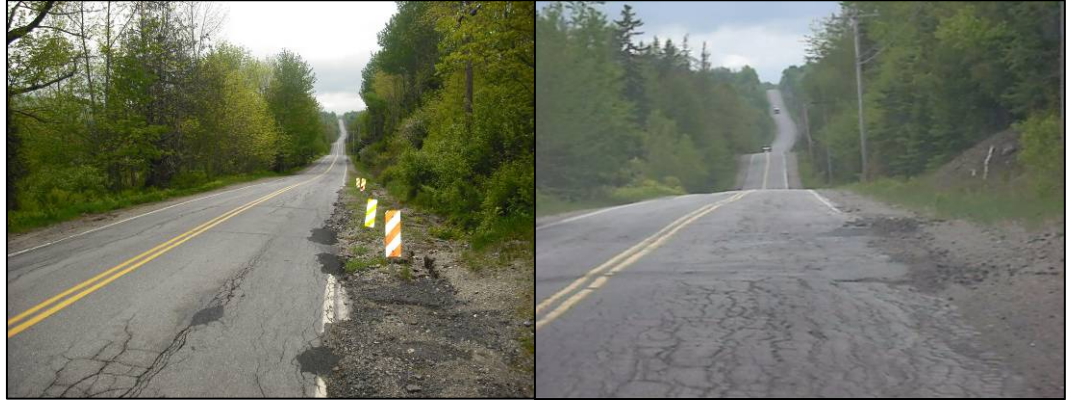
Photo points 4 and 5, see Map 2

There are also several areas where the never-paved shoulders are crumbling into the travelled way and

where they wash out every year. Most of the shoulders are very soft and many are steeply graded creating very dangerous conditions if a tire goes off the road surface. Large trucks often cross the center line to avoid the shoulders creating additional hazards for smaller vehicles. The portion of Route 191 in photo points 4 and 5 was not repaired in the summer of 2010.

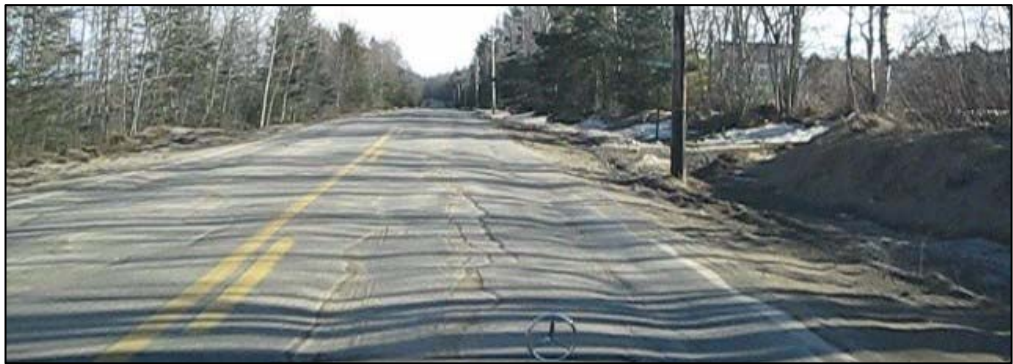
Photo point #6, see Map 2

The result is unsafe conditions particularly at night and in severe weather. The road surface has

deteriorated as described above (multiple longitudinal cracks, eroding shoulders and road surface) and is nearly impossible to maintain in winter weather because of extensive longitudinal tire ruts that create an undulating road profile from shoulder to shoulder. Photo point 6 is in an area that was only resurfaced in July, 2010.

The road surface has deteriorated (multiple longitudinal cracks, eroding shoulders and road surface) and is nearly impossible to maintain in winter weather because of extensive longitudinal tire ruts that create an undulating road profile from shoulder to shoulder. A very short stretch of Route 191 on Cooper Hill was reconstructed (with 4 foot shoulders) in the summer of 2010 and a significantly longer area was only resurfaced (no shoulders). Many of the portions that were resurfaced will return very quickly to their previous condition with the weight of trucks and winter weather.

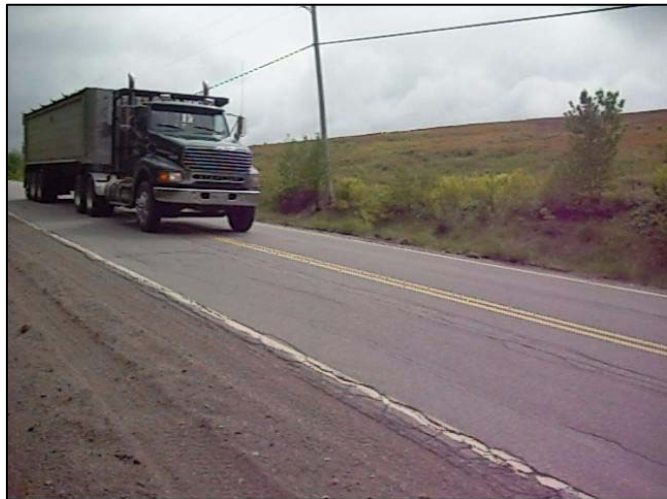
Photo point 7, see Map 2

Route 191 has no paved shoulders on either side of the road for the vast majority of its length in the town of Cooper. The shoulders are unpaved and very soft, the ditches are deep and the edge of road surface is crumbling in several locations. Map 2A depicts the vehicles that have ran off the road in summer and winter conditions. One resident flipped their car when they ran off the road due to the soft shoulders.
